ECi Cylinder AD Information

by Tony Saxton - Director of Tech Support, The Twin Cessna Flyer

August 18, 2016

AD2016-16-12 becomes effective Sept. 15, 2016 and calls for simple removal from service the specified model/serial number cylinders base on a time-in-service, graduated replacement schedule of specific cylinders produced by the now closed ECi (Danbury Holdings Inc.) between 2002 and mid 2009.

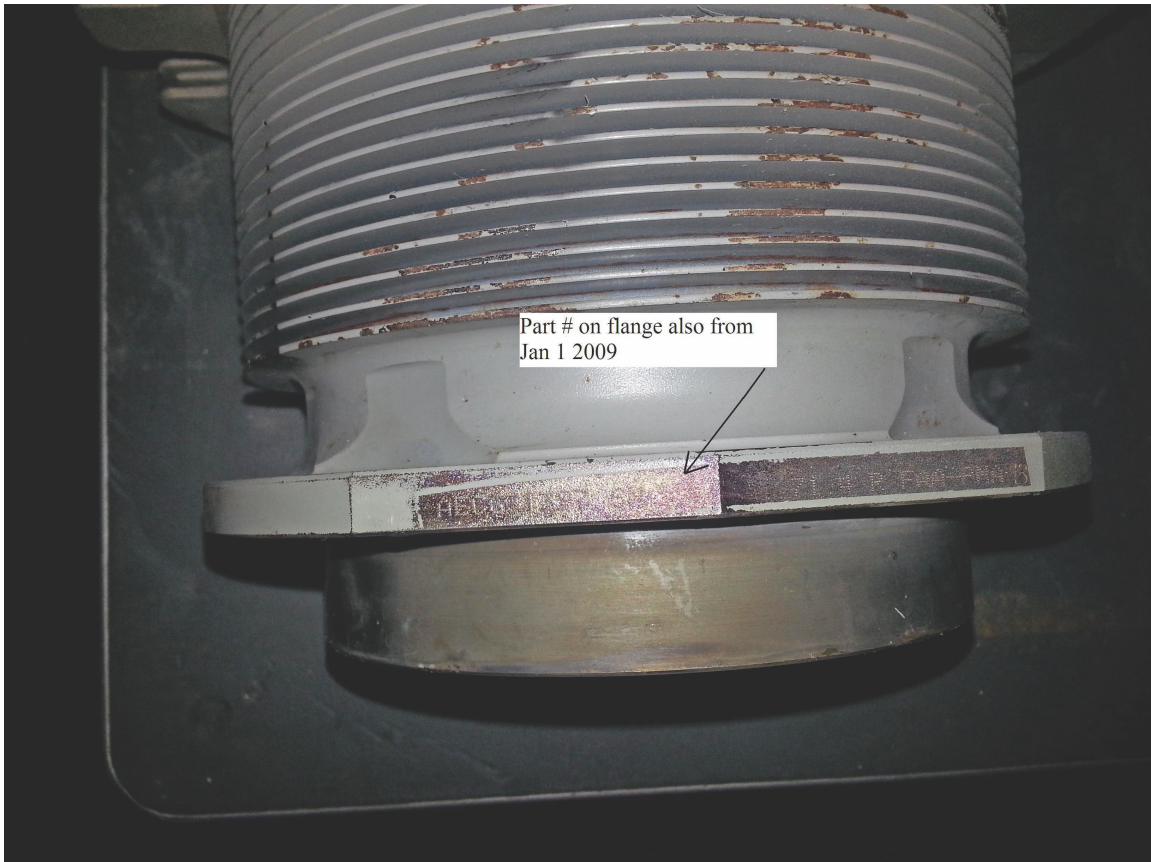
Some of the affected cylinders manufactured after January 1, 2009 will have the part number on the lower flange up near the engine case (Figure 1) but these numbers are never visible on an installed engine.

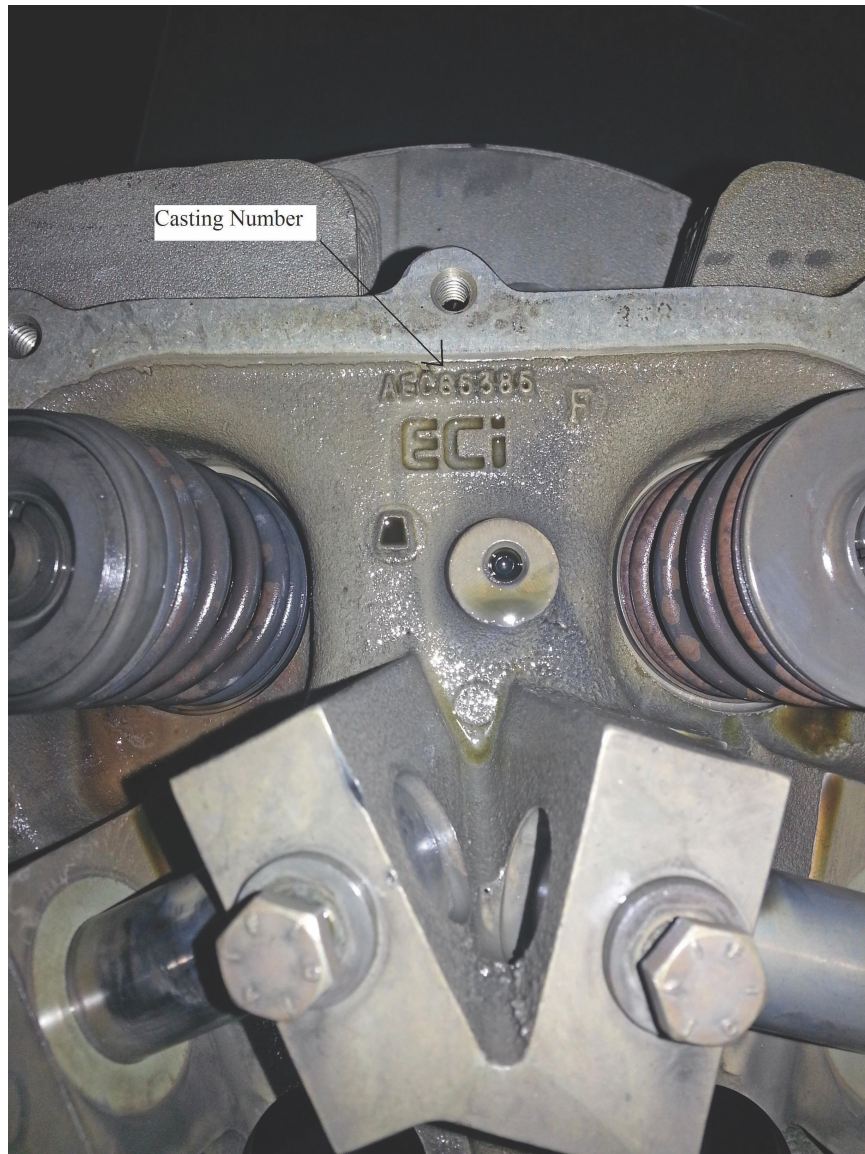
(Figure 2)

The most certain way to identify the affected cylinders is to remove the rocker box cover and look for the cylinder casting number of “AEC65385” (Figure 2 - next page)

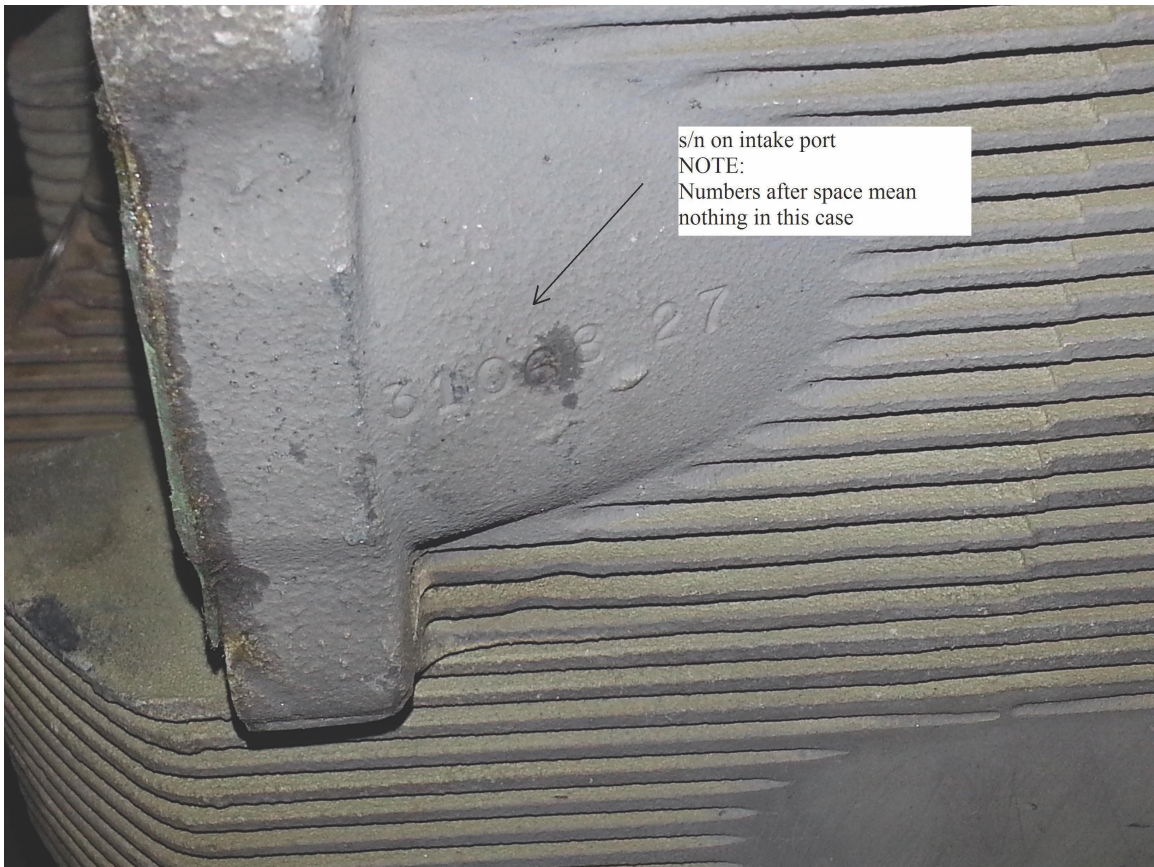
(Figure 3)

Early generation affected cylinders had the serial number stamped on the intake port on the side of the cylinder (Figure 3 - next page) These numbers are impossible to see when the cylinder is installed.

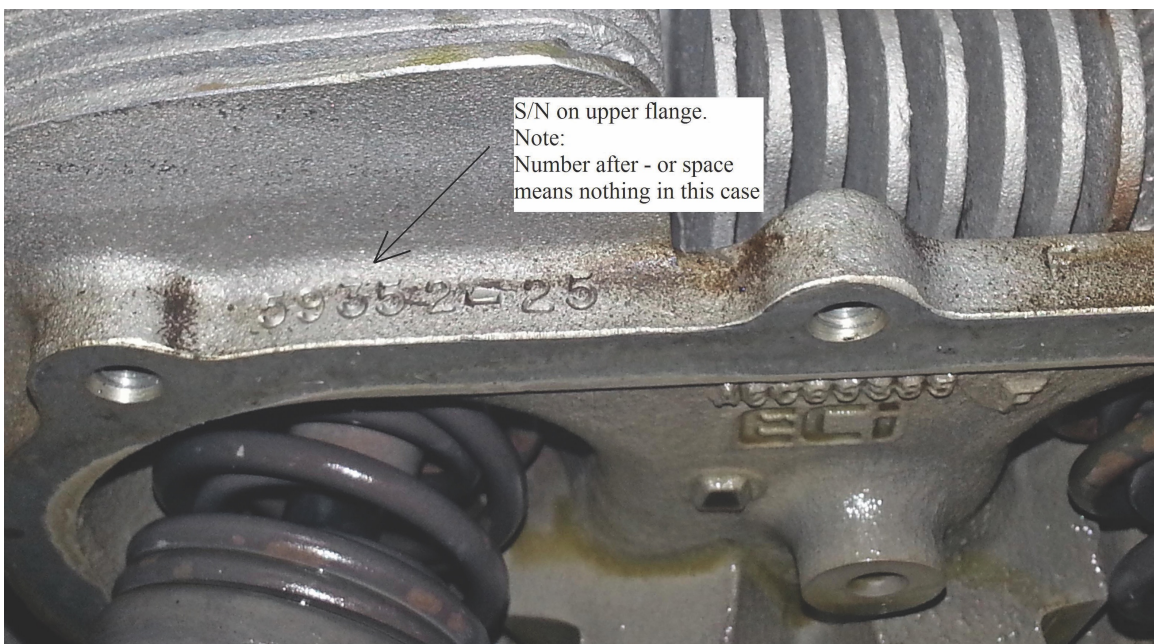
(Figure 4)

On Jan 1, 2009 ECI started to stamp the serial number on the upper flange of the cylinder just behind the rocker box. (Figure 4 - below) This arrangement is very easy to see and identify the serial numbers.

If the cylinder has the casting number of “AEC65385” and the serial number is on the upper flange where you can see it, and if that number is 61176 or lower, then the AD note applies. If the upper flange serial number is higher than 61176, the AD note does not apply.
