310Q GEAR MISHAP

by Euel W. Kinsey, TTCF Member

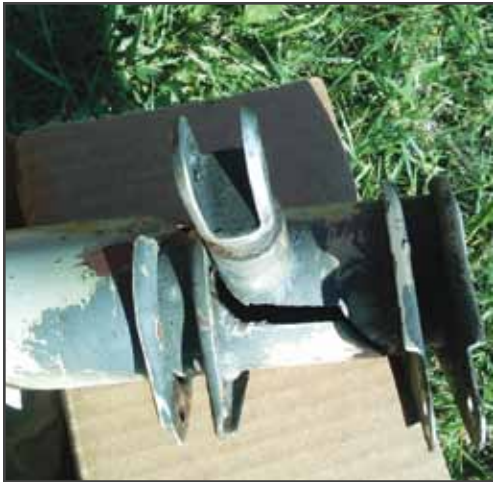
Upon inspection of the left gear mechanism at my hangar, the torque tube had a spiral fracture which seemed to begin at a weld and extended almost halfway down the tube. I consulted with my mechanic of more than 20 years, and we decided that since the floor was going to have to come up to access the gearbox, we should just take the plane down for annual inspection a month early. I ordered the torque tube, and the mechanic replaced it and spent quite a bit of time readjusting the gear using the "Rig It Right video" and the service manual as references.

My gear incident occurred after we replaced this MLG torque tube and completely re-rigged the landing gear.

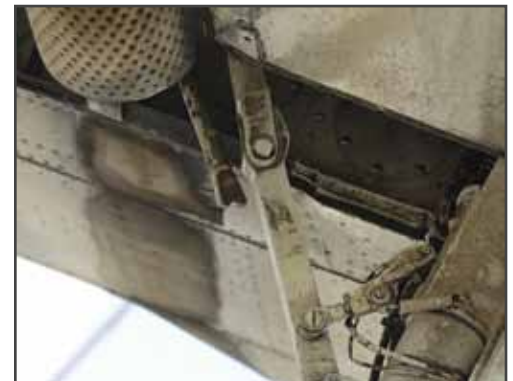
Upon landing, we surveyed the damage. Here is the broken end on the MLG outboard drive tube.

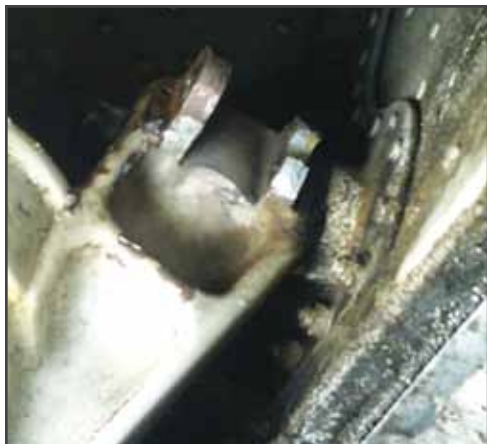
I exited the plane and got a bear hug from my mechanic who was obviously relieved that this ended so well. A television news camera was in my face almost immediately. My mechanic then pointed out that the overcenter pieces on the left landing gear were missing! The attachment tab had broken off of the upper main gear trunion. The parts were gone and the microswitch was hanging by the wires.

Broken ear on main landing gear upper trunion at lock link pivot bolt point.

Thus, it would seem to me that the left gear actuator was stressed and adjusted too far, which wouldn't allow the right gear to completely extend. Thus, the connection on the upper main gear trunion failed. Perhaps the binding main gear pivot bolts contributed to this.

I can only speculate that the prolonged time in the air after the emergency manual extension locked the gear into place sufficiently that it held on landing. Needless to say, a lot of parts needed to be replaced, the most expensive being the upper main gear trunion. Removing this part proved to be a real chore for the mechanic. The forward main gear pivot pin was extremely difficult (almost
