LANDING GEAR EMERGENCY

by Ingo Steinbach, TTCF Member

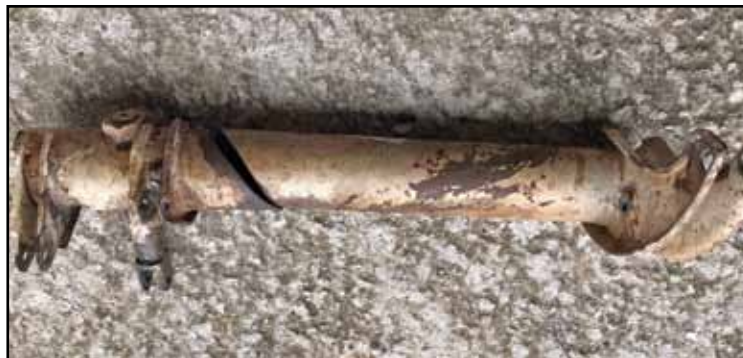
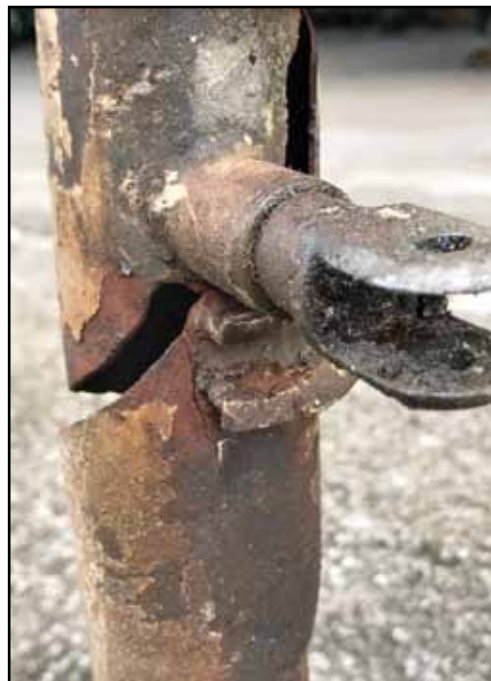
I began the landing sequence, touching down on the right main first with sufficient power to maintain straight-and-level flight and then gently lowering the left, very slowly increasing the load. It held! I ever-so-gently braked straight ahead and taxied to the hangar at a snail's pace. As we exited the airplane, I was baffled by what was going on. Was it just a light or switch? What about the unusual trimming I had to do? I got a flashlight and as soon as I looked in the gear well, I spotted the problem: a ruptured torque tube. Of course, I had inspected these carefully at the prior annual inspection and they were fine. Note that in the pictures to the right, its condition is deteriorated due to being exposed to a hot, humid climate in the

three months since removal. I began the repair process. First, I installed an electrical patch with two switches on the outside of the aircraft that allowed me to move the electric landing gear motor up and down in small increments, pausing at any point in the process. This patch was very helpful in the disassembly and re-rigging of the landing gear. As I raised the gear, I saw that with the damaged torque tube, the left main gear could only retract partially, a few degrees upwards. It had hung in the slipstream causing the additional drag and yaw I had experienced.

In my case the torque tube was seriously disrupted, unable to transfer the required torque. Our tests showed that the broken torque tube was still able to remove the downlock up to a degree that the left main gear would dangle free. It could not develop the torque required to fully retract the left main gear any more.

Intimidated by the potential of a gear failure without prior warning, and also to gauge how close I was to a gear up landing with the broken torque tube, we measured the force needed to break the downlock position on the defective side; only less than 40% of the required value as per rigging instructions in the maintenance manual was necessary to break the downlock and make the gear collapse! A less than butter-soft landing could have done this!

MLG torque tubes have been a known problem area for decades. In spite of a new, more robust version they can still fail. The culprit is usually corrosion which can start on the inside of the tube, making detection difficult.

From the Editor: *Main landing gear torque tubes have long been a service problem in Twin Cessna aircraft with electro-mechanical landing gear. In May of 2009 Cessna released Service Bulletin MEB09-2, which specified the replacement of all older tubes with new style tubes, also detailed inspection requirements. A copy of this service bulletin can be found in the Technical section of our website at www.twincessna.org.*
