# MAIN LANDING GEAR TORQUE TUBES

*by Tony Saxton, TTCF Director or Tech Support*

In May of 2009 Cessna released Service Bulletin MEB09-2 which specified the replacement of all older tubes with the new -33 and -32 tubes.

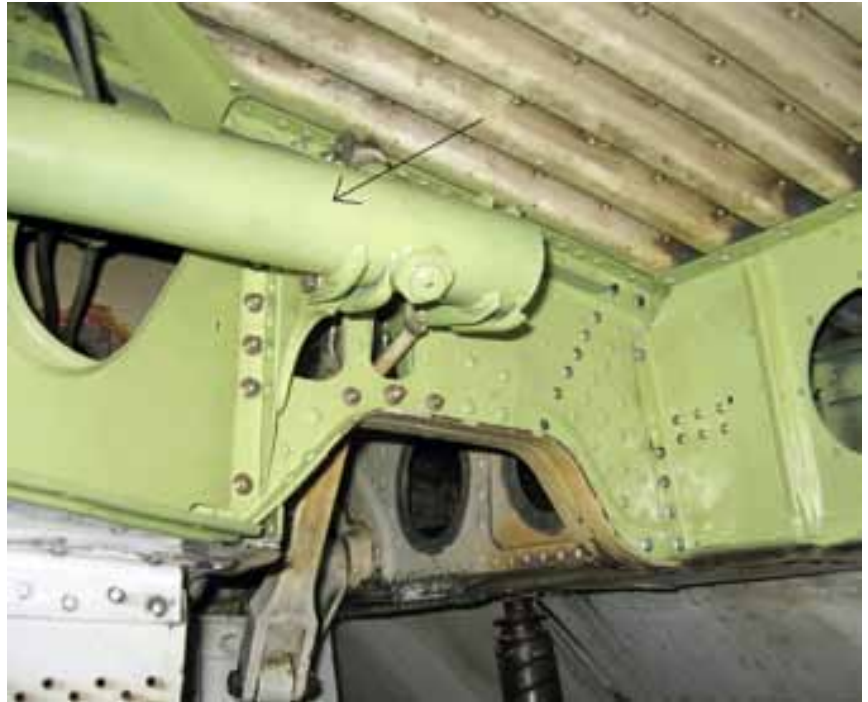
*New MLG torque tube installed (along with new side brace kit).*

All torque tubes other than -33 and -32 tubes must be replaced.

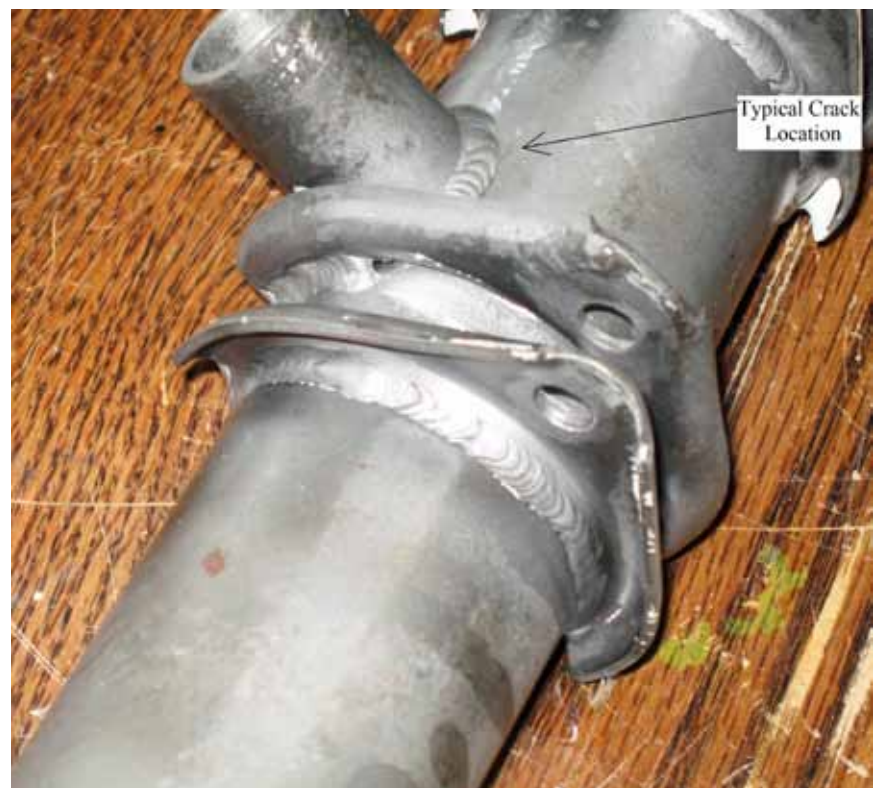
The MLG torque tubes have long been a service problem in the Twin Cessna aircraft with electro-mechanical landing gear. Reports of cracked, corroded, and broken tubes were being reported in Service Difficulty Reports as far as you want to check.

*Typical crack location on a MLG torque tube.*

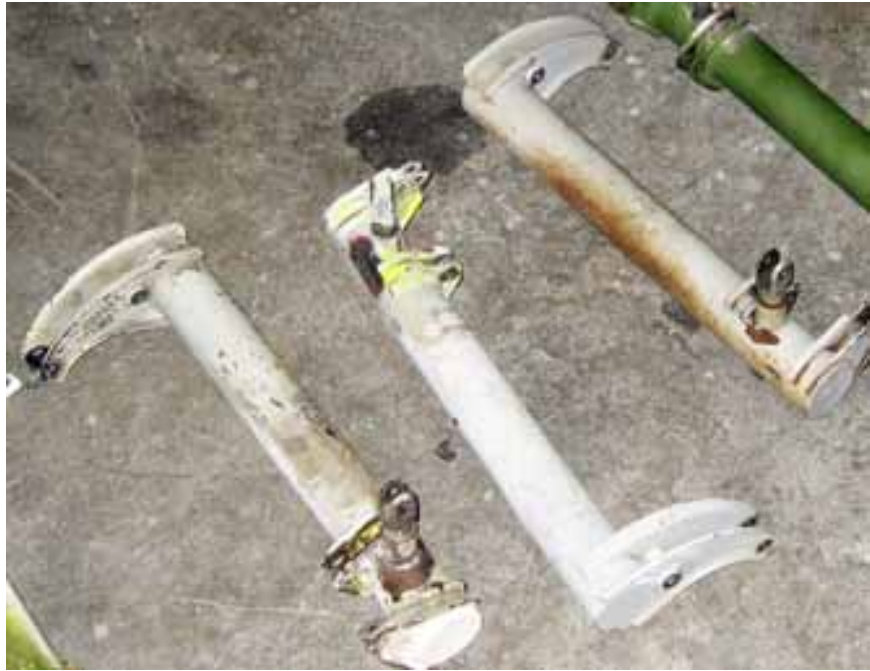
*Just a sample from my bad torque tube collection.*
