RIG IT RIGHT!

Proper Landing Gear Rigging Procedures

Cessna 300 and 400 Series Twins

SUBJECT: WING RIB IMPROVEMENT -- MAIN LANDING GEAR SIDE BRACE

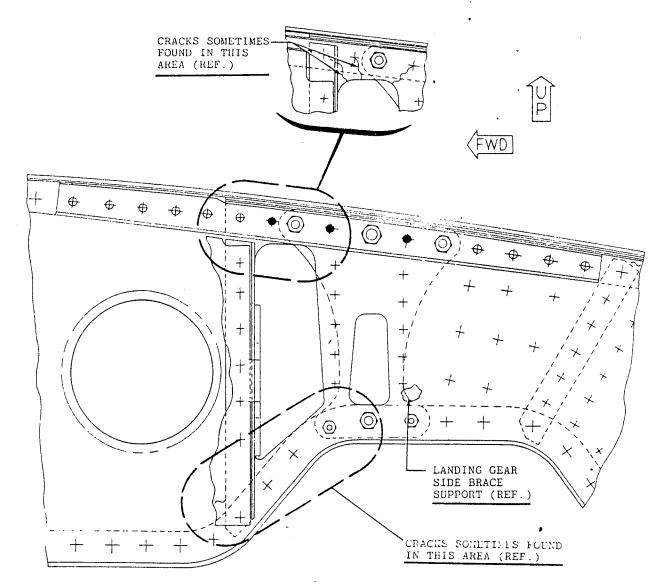
VIEW LOOKING GUTEGARD AT RH MAIN GEAR WHEEL WELL INBOARD WING RIB (LH OPPOSITE)

- 1. Inspect wing ribs in LH and RH main landing gear wheel wells, at main landing gear side brace supports (forgings) upper and lower attach points for cracks and insure support attach bolts are tight, torqued in accordance with your aircraft service manual torque values.
- Cracks are sometimes found in the existing doubler on inboard side of wing rib, at
 the top of the cut out in rib web for the aft push-pull tube (torque tube to landing
 gear bellcrank) and near the landing gear side brace support, upper and lower attach
 bolts.
- 3. If cracks are existing in the wing rib, repair rib by installing Service Kit SK414-8, Wing Rib Modification Main Landing Gear Side Brace.

At any time cracks are found on in-service aircraft, the wing rib is to be repaired by installing Service Kit SK414-8E which incorporates the same structural improvements mentioned above.
