ANATOMY OF AN EXHAUST VALVE FAILURE

By W.B. "John" Johnson, TTCF Member (and Tony Saxton)

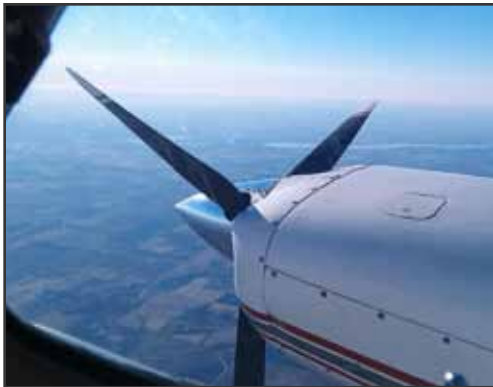
Failed exhaust valve results in engine shutdown and slow ride home for Thanksgiving.

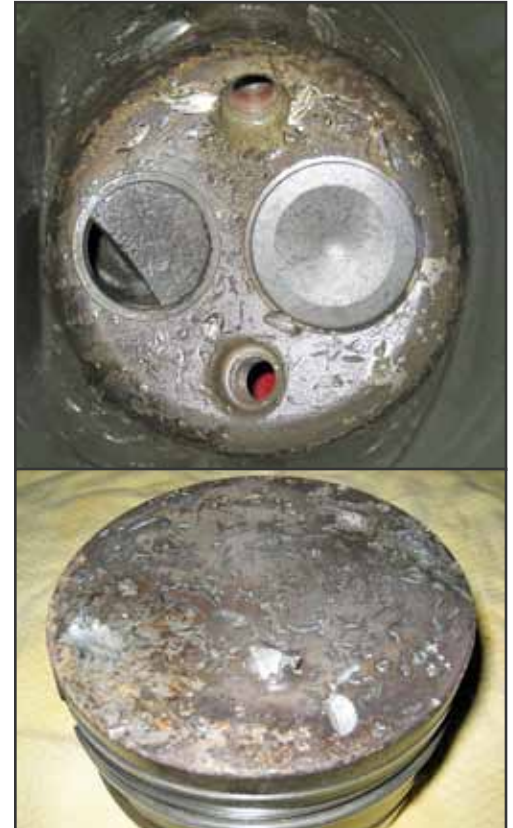
of airports within gliding distance and we were almost home, so we decided to continue on 1 ½ engines with hawk-like eyes on every gauge. The upshot was that a stuck exhaust valve had broken and exited the engine via the exhaust system, trashing the turbocharger on its way out. More big bucks were sucked into the black hole and we were airborne once again.

Broken valve #1 and the damage it caused before exiting the cylinder and the airplane through the exhaust system.

The starter adapter failure was an "It happens" thing. After the first exhaust valve failure, I sent some photos (see above) of the carnage to the Cessna Pilots Association. According to Mike Busch (and later confirmed by Tony) the first failure had the ear marks of a stuck valve – rare in big bore Continentals.

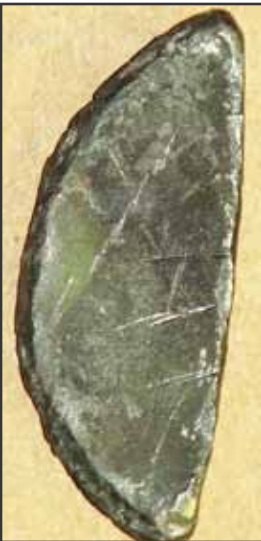
Upon investigation, we learned the #2 cylinder exhaust valve face fractured. We found the fragment in the intake crossover pipe so there was no turbo damage. Lucky me. Two more T notes in The Hole and I was back flying again.

Exhaust valve piece from failure #2. We found it in the intake crossover pipe.

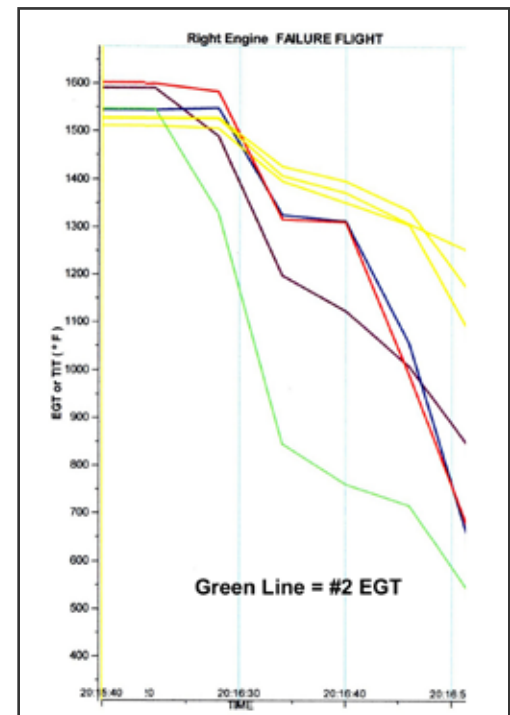
On the failure flight the valve head section separated causing massive compression loss and for the most part the cylinder quit making heat, and power, thus running rough. You pulled the power off to relieve the roughness

When the valve failed, cylinder temps plummeted due to massive compression loss.

and as you did cylinders 4 and 6 dropped temps a lot more than the right bank of cylinders. This is a result of way the induction system is built. With the left bank receiving air from one single intake runner the failed valve in the #2 cylinder acted as a huge air leak and effectively reduced the MAP (air) in cylinders behind it. Less air = less power = lower temperature. This is all a normal failure mode and if the failed valve piece didn't enter the other cylinders they'll be fine.

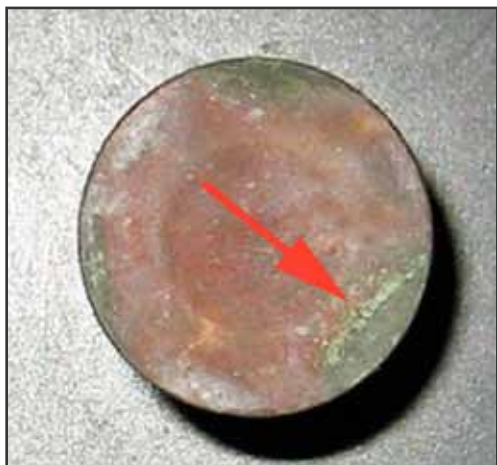
in the picture on p. 22. At that time the cylinder could have been repaired with a minimum of fuss.

Here's what a borescope inspection might have shown several flights prior to failure. Heat damage due to leaking exhaust gases is clearly visible.

How Would I Proceed? Continue with oil analyses specifically watching for any increase in nickel. Do a borescope inspection and compression check of all cylinders at each oil change. Finally I would download and graph each flight and watch for any indication of these cyclic spikes in EGT. If they occur have the cylinder borescoped immediately [emphasis added]. If any indication of exhaust valve stress is noted remove and repair the cylinder before the valve fails." - Tony
