# INTERIOR RENOVATIONS - PT. 1

by Dennis Wolter, Founder & Owner, AirMod Inc.

## Old Airplanes, New Challenges

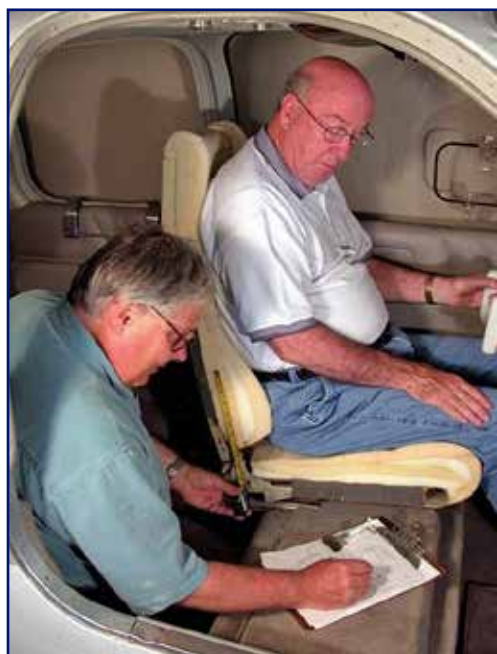
*Custom fitting in a seating station to ensure correct ergonomic geometry that accommodates the physical dimensions of the pilot.*

ensuring that the lumbar, thigh, and cervical (neck) shapes on the seat are carefully dimensioned to comfortably accommodate the person sitting in that seat. The other seating stations will be ergonomically dimensioned to accommodate what the physical design world considers to be the current 'standard measure of man.' Building a seat to these dimensions will comfortably accommodate 90% of adults. It is not uncommon for us to custom fit a favorite seating station for a spouse or other frequent flyer.

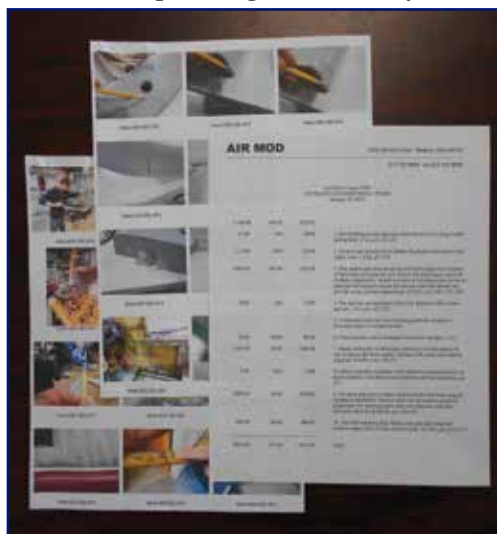
*Typical tear-down report and supporting photos.*

With the airplane back in our hangar after the avionics check, we begin the eye-opening process of disassembling and inspecting the entire cabin, components and systems, and documenting our findings, enabling us to create an itemized "tear-down report" complete with photographs and cost estimates of repairs needed. This information is emailed to the customer within ten days of project start-up. And the pictures don't end here. As we progress through all stages of the project, we send the customer updated images of repairs being made and work being completed. A phone call accompanying the emailed pictures keeps everyone up to date as we progress. Stay tuned next month as we continue to walk through every revealing step in this process. Until then, fly safely!

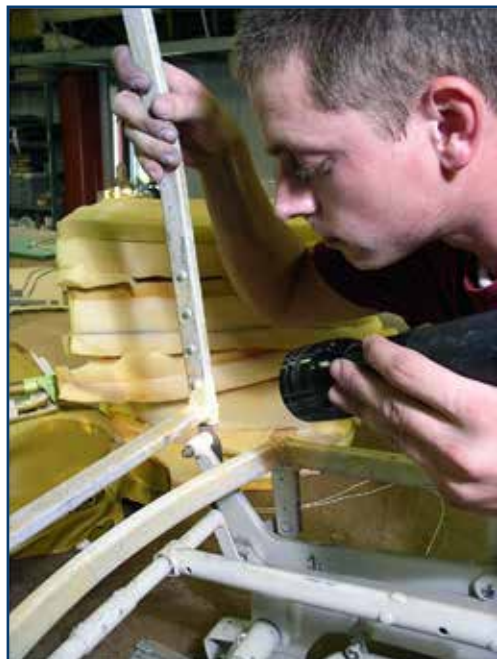
*Inspecting a stripped seat frame for structural integrity and mechanical condition.*

the removal and careful storage of every interior component. We begin by removing, stripping, and thoroughly inspecting the seats. We look for cracked seat frames, worn tracking rollers, feet and seat stops, as well as the function of reclining mechanisms and passenger restraints. These components are what protect the occupant in the event of an accident. It's surprising how often we find seats and seat belts that are in service but not in airworthy condition. Seat issues we see too often involve missing, damaged, or homemade seat stops. These seemingly innocuous little items are a very important part of the seat structure. Missing or incorrect seat stops can lead to a seat coming off its mounting rails during an accident. Need I say more?

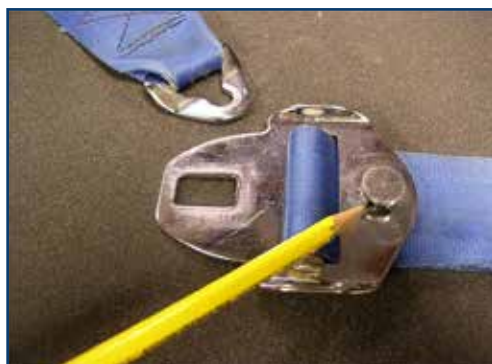
*The nylon retaining sleeve that snugly holds the shoulder harness in the seatbelt buckle is often badly worn or missing, contributing to possible disconnection of the shoulder harness.*

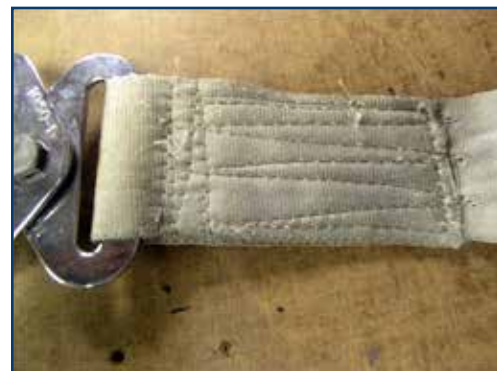
*Homemade seatbelts: Note unapproved sewing and stitching pattern and absence of required certification tag.*

As the seats are being removed, careful attention is paid to seat belts and shoulder harnesses. We often find incorrect mounting hardware, worn webbing, and believe it or not, belts that were re-webbed using a home sewing machine; this type of stitching will not hold up in an accident. Everything here must conform to FAA approved standards. Remember this: "You can't write the check on the way down."

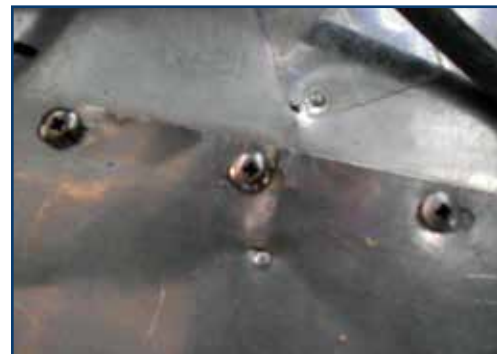
*Damaged floorboard.*

With seats removed, it's time to remove the floor carpets. We get a first look at the condition of the floorboards. Often these thin aluminum floor panels are damaged. We also remove the floor-mounted quick release mountings, which are often so worn or compromised with years of dirt accumulation that they do

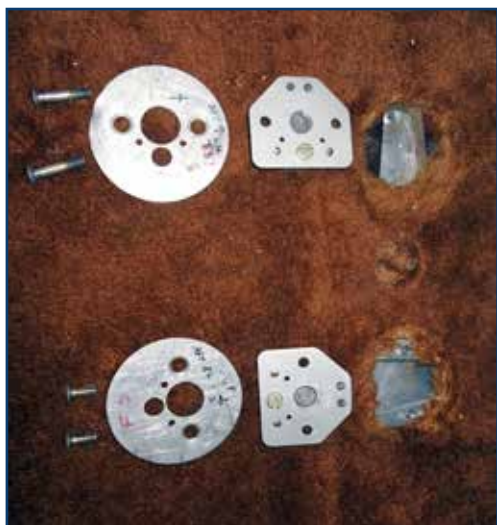
*Floor-mounted aft seat mounts.*

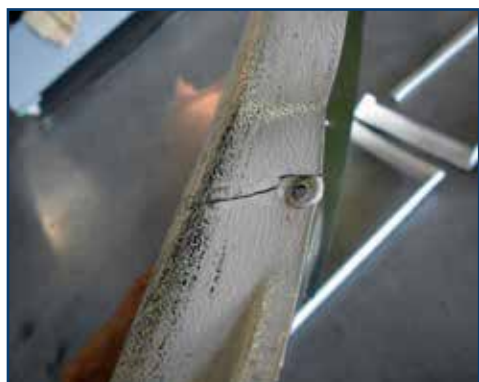
*Typical condition of a 40-year-old plastic window frame.*

Next item on the tear-down list is to remove the plastic window trim, armrests, and side panels. The old plastic window trim often necessitates extensive repair or replacement. Fortunately, Plane Plastics makes most of the replacement plastic parts for almost all of the piston Cessnas, including twins. However, these approved aftermarket parts do require some trimming and fitting to achieve a quality installation. If an original part can be economically repaired, we will rework and reinstall the original piece.

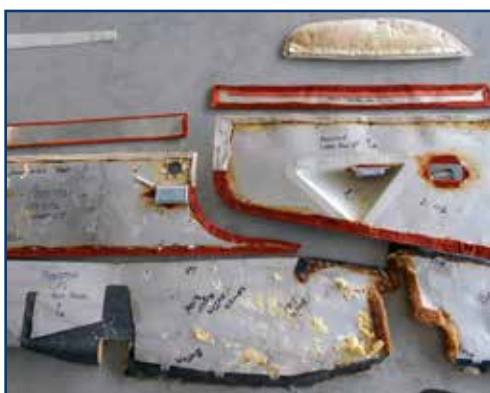
*Almost every older Cessna twin will require new, more durable side panels and armrest mounts.*

With the window trim removed, we remove and inspect the armrests and side panels. Cessna originally fabricated the side panels using very thin .016" aluminum. Years of removal and reinstallation due to avionics installations, maintenance, or an interior change or two means these old side panels will have to be newly fabricated using more durable .020" and .025" aircraft aluminum.

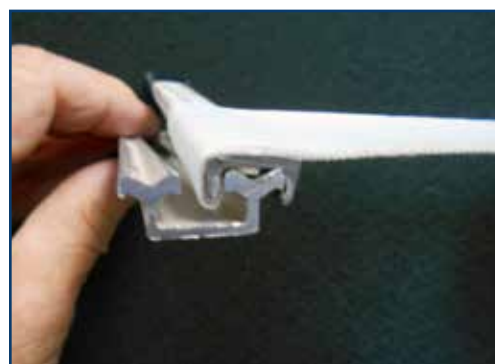
*Extruded aluminum headliner retention rail system found in newer Twin Cessnas.*

The next interior component to be removed is the headliner. Cessna employed two different ways to hang a stretched vinyl or cloth headliner in their piston twins. The earlier models used a system of sewing a canvas loop at the edge of each full-length headliner seam. A long, tempered 1/8" diameter tempered steel rod is run through the canvas loop. Cessna installed clips at each bulkhead between the upper aft end of the windshield frame and the aft cabin bulkhead. The clips would hold the rods securely as the headliner is hung, stretched, and bonded to a lengthwise longeron above the cabin windows. Removing this type of headliner involves pulling the outer edges of the material loose and unclipping the rods at each bulkhead.

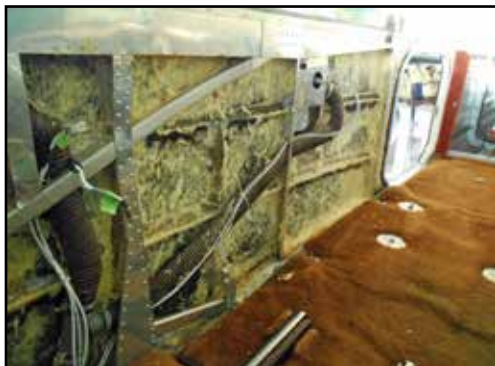
*Tar-covered cabin skins and structure.*

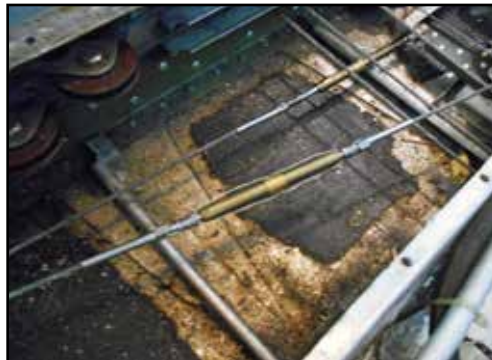
*Typical oily mess found in the belly of a 40- to 50-year-old piston Twin Cessna.*

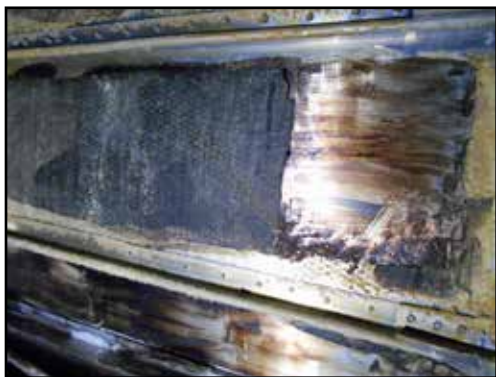
*Skin damping tar partially removed by careful heating with a heat gun and scraping with a plastic scraper.*

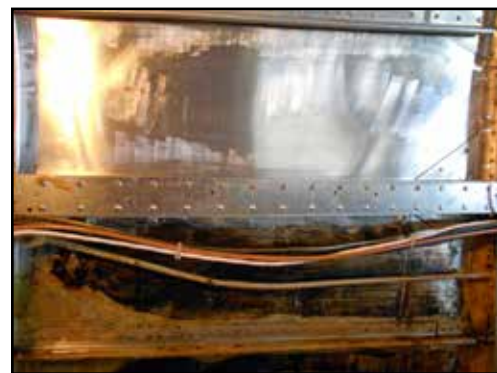
*One section of a 310 cabin side skin, thoroughly cleaned with Scotch Brite and lacquer thinner.*

The process begins by removing all the old fiberglass residue with handheld wire brushes. Then we carefully use heat guns and plastic scrapers to remove the bulk of old skin damping tar. Next comes the tedious process of using a mix of lacquer thinner and mineral spirits to remove all the remnants of tar residue. Now it's time to use Roloc rotary abrasive wheels and Scotch Brite to remove any corrosion from the bulkheads, stringers, and cabin

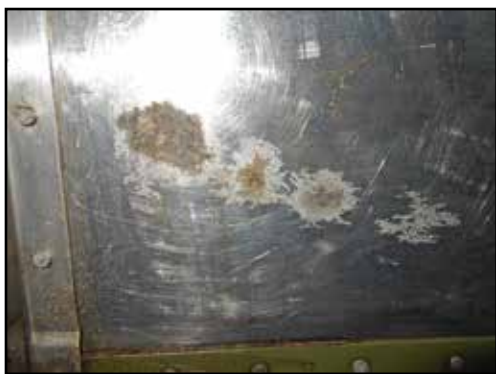
*Corrosion often seen on a cabin side skin once the tar is removed.*

between mating structural components. This entire process takes several days. Antiseptically cleaning the cabin from forward to aft bulkheads, top to bottom, and deep into spar areas allows the zinc chromate to help protect the entire cabin area from future corrosion.

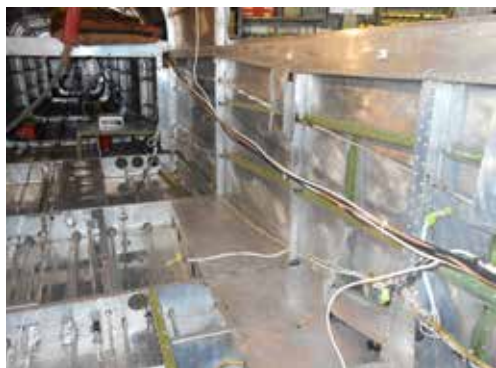
*A 310 cabin, antiseptically cleaned showing partially masked wiring, cables and servos, almost ready for the application of zinc chromate.*

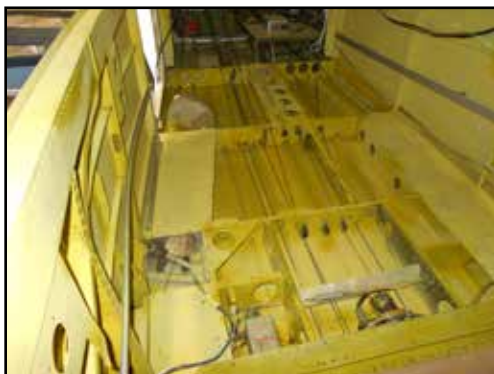
*All chromated and finally ready to proceed with the interior renovation.*

After everything is sprayed with zinc chromate, we will carefully apply Corrosion X or ACF50 to hard-to-reach places in both the main and aft spar areas as an extra precaution in our fight against corrosion. These airplanes are not replaceable, and it's rewarding to see the passion that folks put into their ownership.

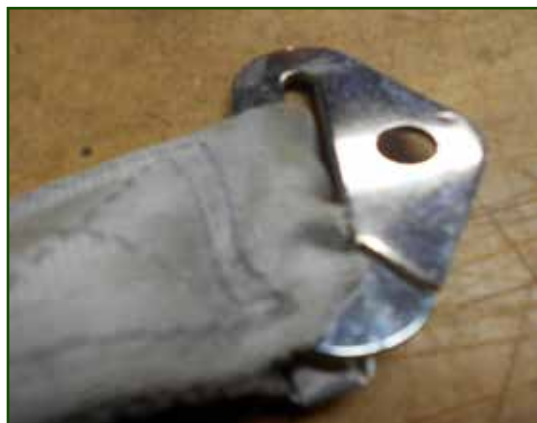
Left: Badly damaged seatbelt attach fitting. All repairs or reconditioning of passenger restraints and their mountings must be done by an FAA certified repair station where they can repair, certify, and quickly ship the belt back to the customer.

Right: An un-airworthy, 'found object engineering' attempt using rubber grommets to replace the nylon locking bushing that secures the shoulder harness to the lap belt. No, thank you.

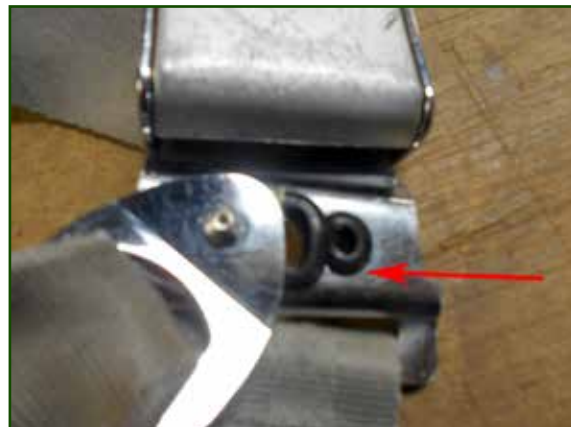
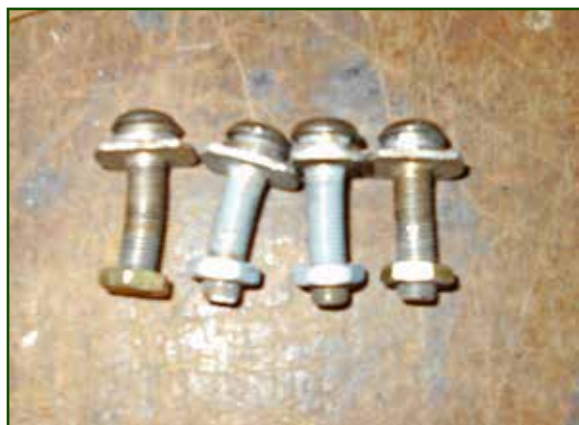
Left: Bent mounting lugs that secure the 5th and 6th seats to the quick release floor hard mounts in a 310. Bent lugs usually result in the seat not being completely locked in place. These mounting lugs also secure the seatbelts to the airframe. Yikes!

Right: Welded repair on an articulating pilot seat back support brace. Cracks are often found in this critical seat component. The best fix is to replace the brace.

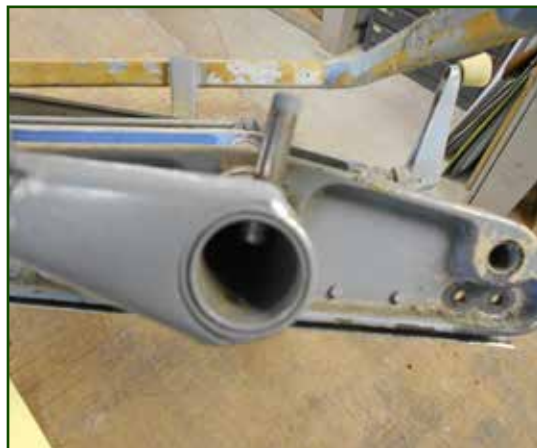
Left: Here's a common problem in all Cessna seats from 150s through 421s: loose or shifting roll pins. The fix is to reset the pins and secure them with safety wire. Be sure to inspect whatever component is being secured with these pins for elongated holes or cracks that would require replacement of the damaged component.

Right: A non-approved sewing job done in the field, securing a seatbelt to a mounting end fitting; note the absence of a certification tag. Again, this work must be performed and documented by an FAA-approved repair facility.

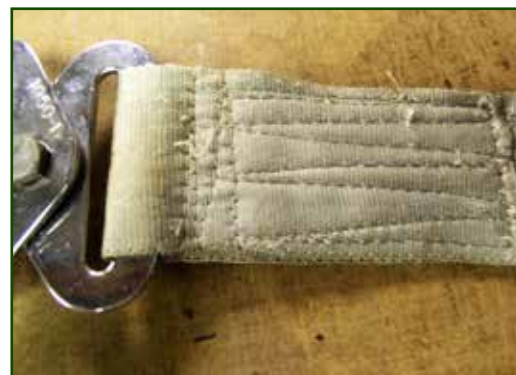
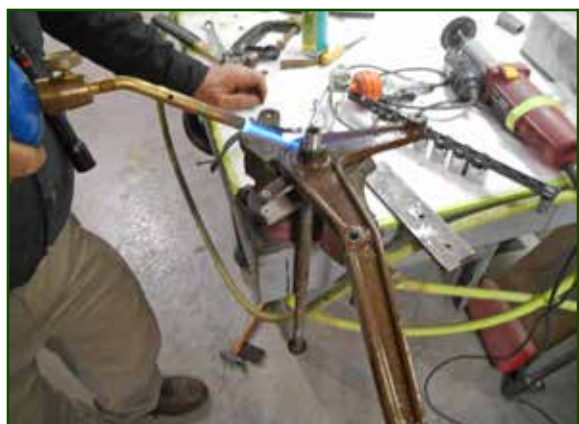
Left: Here is another common seat issue. Almost all seats in Cessna twins have moving parts. In owner-flown airplanes, the pilot seat gets adjusted for the one pilot who flies the airplane and is usually not adjusted for several years. These seats often go without regular lubrication, and corrosion builds between the steel and aluminum parts. The result is a frozen seat adjusting system. In severe cases, the careful application of heat, penetrating oil, and lots of patience is the only fix.

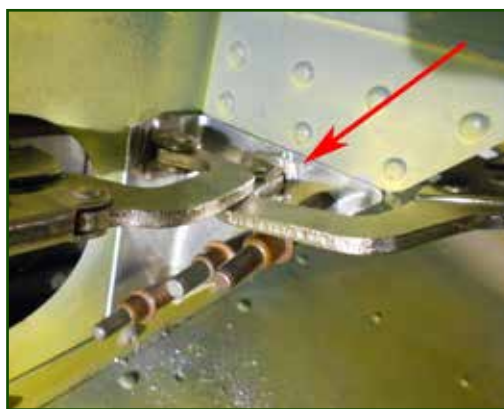
*Left:* Cracked pilot seat support bracket in a 310. The fix is a heavy 2024T-3 aluminum doubler.

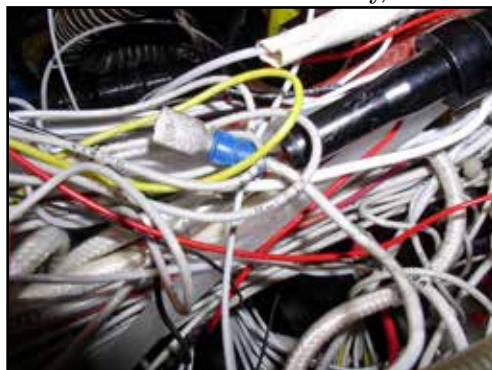
*Messy wiring, along with abandoned wiring, unprotected connectors and unidentified inline fuses.*

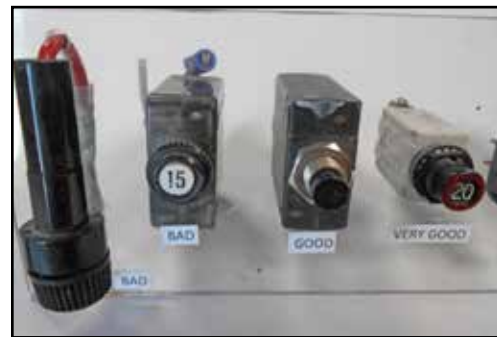
*Here's an image of the four most common circuit protection devices used in light aircraft.*

I am a big believer in pullable circuit breakers. Pullable breakers allow the pilot to better manage electrical and avionics equipment.

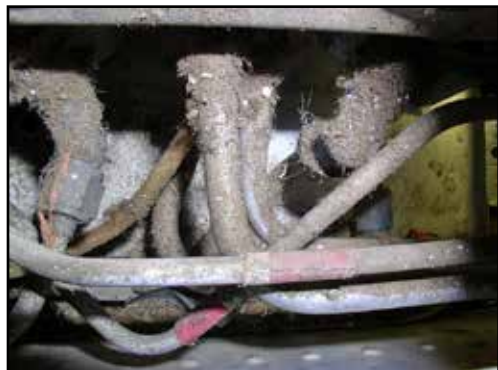
*Keep critical systems clean. Dirt can hide a serious problem.*

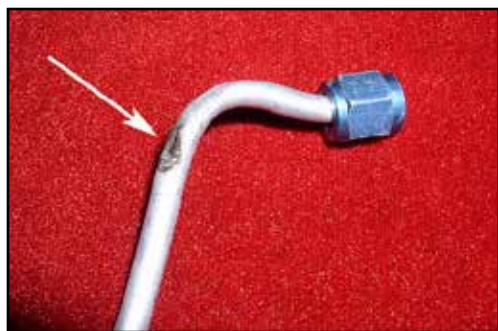
*A corrosion-induced hole found in an aluminum fuel line located deep in the filthy complexity of fuel lines seen in the previous photo.*

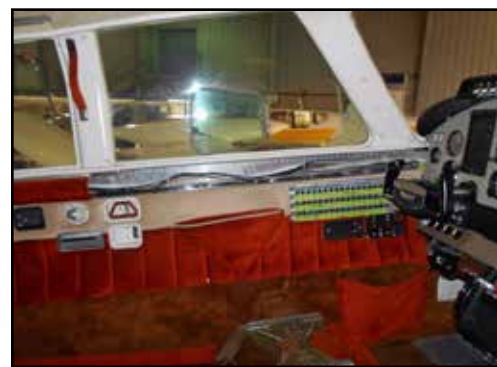
*Every interior trim component shown in this photo of a 20+ year-old aftermarket interior was found to burn, including all of the cabin insulation.*

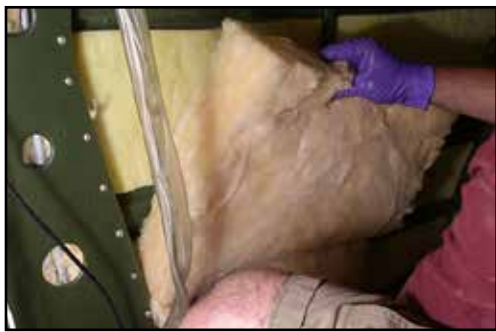
*AA-approved flame retardant upholstery materials and insulation will not support the ignition or spread of a cabin fire, especially the insulation shown in this photo.*

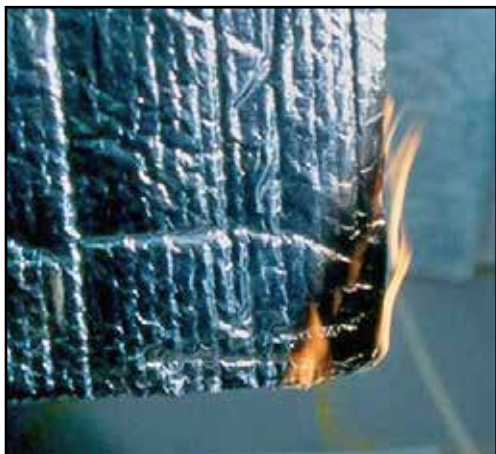
*A picture is worth a thousand words: household water heater wrapping used as insulation in a 421.*

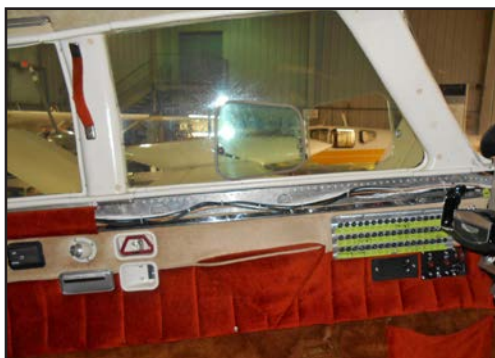
*Typical plastic armrest and side panel design in a 60s Cessna twin. One large, very thin sheet of aluminum with a plastic, vacuum-formed armrest, permanently mounted by the pilot seat.*

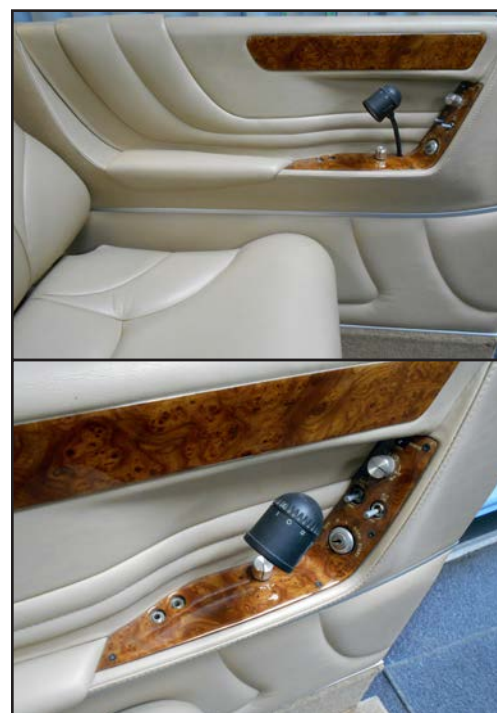
*Molded fiberglass and aluminum multi piece side panels with recessed armrests and convenient, recessed accessory panel. All wood trim is high-gloss hardwood veneer.*

1. The use of multiple panels secured by aluminum extrusions allows for easier removal and reinstallation of the side panels without needing screwdrivers.
2. No more stripped-out mounting screws to deal with.
3. Eliminate the difficulty of

disconnecting and reconnecting the cabin heat ducts to the feed hose in 340 and 400 series airframes by modifying the mounting system so that screws are installed from the front side rather than from the back surface of the lower side panel. Your maintenance technician will love it!

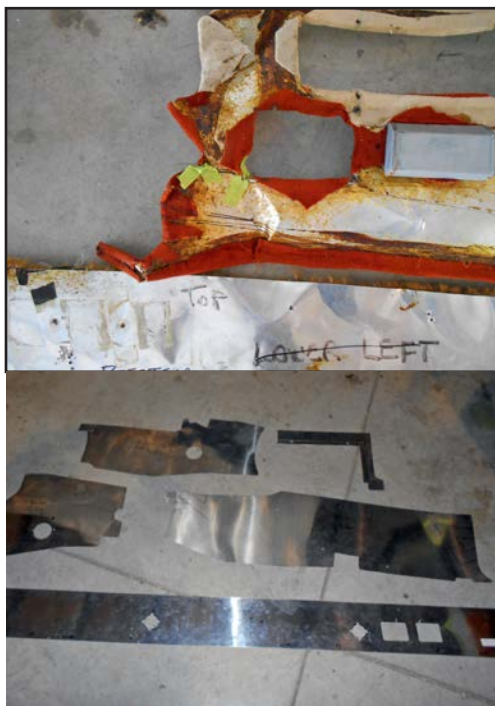
*Top: Typical unusable condition of the large, very thin aluminum factory side panels found in early 310s.*

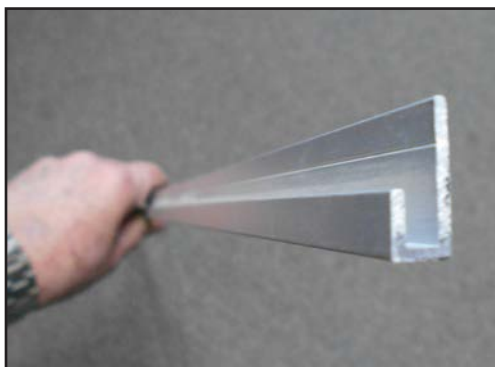
*Extruded aluminum mounting rail that allows a very secure installation of armrests and side panels.*

With side panel design decisions made, we get down to business. As removed, the old thin aluminum side panels were beyond repair, so the decision was made to fabricate all new panels using .020" 2024T-3 aircraft aluminum. The process begins by temporarily installing the new extruded aluminum mounting rails. Then each of the approximately eighteen side panel sections are carefully cut and trimmed to be a little oversized so they fit neatly into the mounting rails. Next, we design, fabricate, and install new support brackets for each of the redesigned armrests.

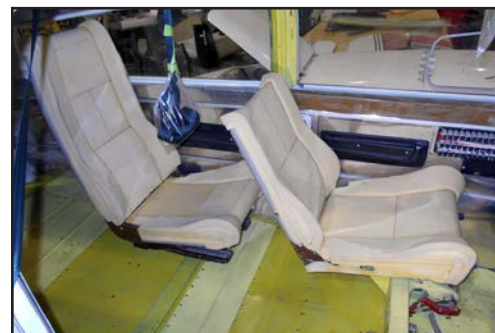
*The unupholstered interior installed in order to double check everything for fit, function and clearance before it all goes into the sewing room for upholstery.*

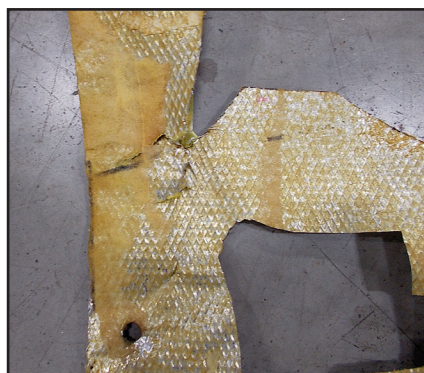
The quilting process applied to .016" aluminum didn't solve the delicate nature of original factory side panels.

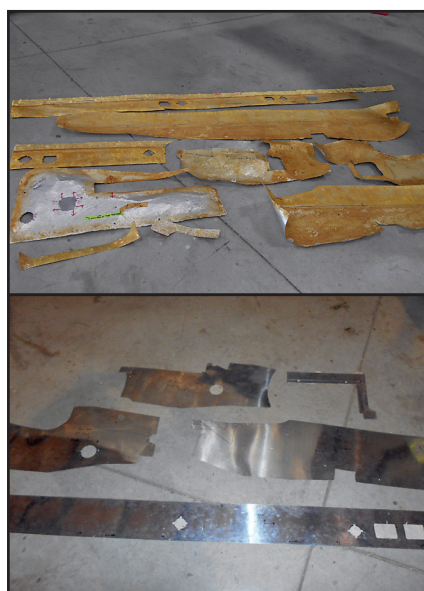
Top: Unusable set of 310R original factory side panels.

Bottom: A new set of 310R side panels, fabricated using more durable .020" or .025" aircraft aluminum.

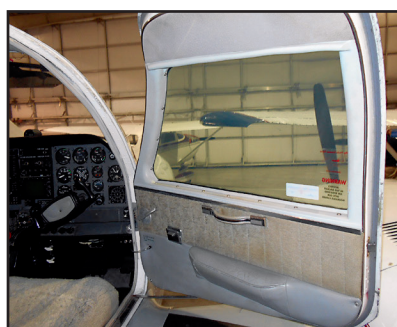
The formed stainless steel edge molding strips installed by the factory in an effort to create a pleasant looking edge closure. This tedious installation process makes it almost impossible to remove and reinstall the thin upholstery panels without damaging the panels, the stainless edge trim, or both.

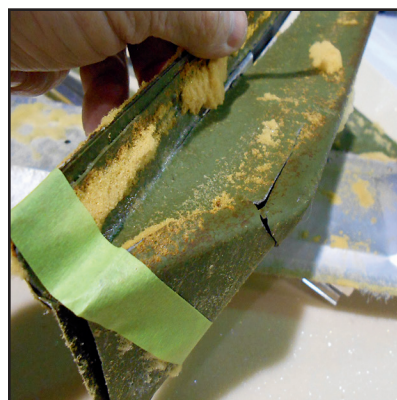
Typical damage found on plastic armrests on later-production wing mounted twin engine airplanes.

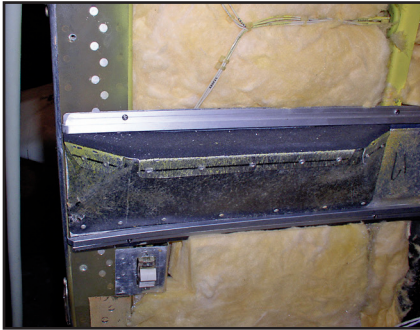
*A rebuilt armrest assembly secured to the cabin side structure with sturdy extruded aluminum.*

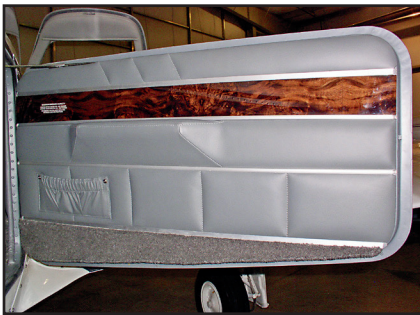
*A finished door panel with hardwood inlay, rebuilt armrest and new .025" aircraft aluminum side panels, all securely held in place with nice-looking extruded aluminum divider rails.*

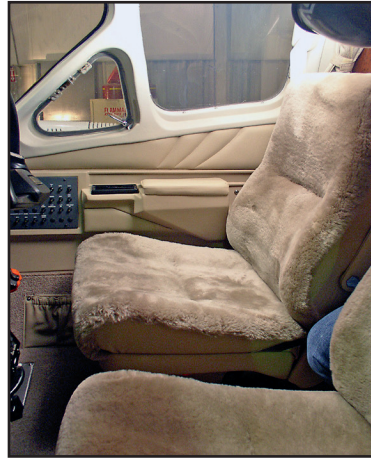
*New, reinforced, aftermarket flight deck side panel armrest.*

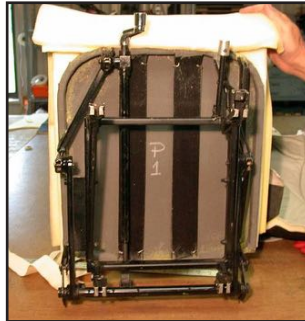
Heavy seat belt reinforcement and new heavy dacron canvas seat base sling.

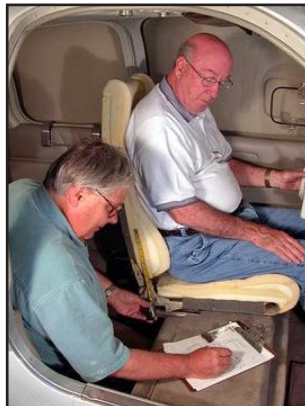
Performing an ergonomic study and recording the data allows our foam builder to create an ergonomically correct and comfortable seat.

**Step 3:** Using dimensions that we created when we did an ergonomic study of the customer, we build new seat foam using three different densities of urethane foam. This custom-shaped foam build is applied to the pilot seat. If requested, we can also custom-fit any other cabin seat in the same manner. The other cabin seat foam builds are typically dimensioned to accommodate what designers refer to as the 'standard measure of man'. These dimensions will comfortably accommodate the physical dimensions and geometry of nine out of ten adults.

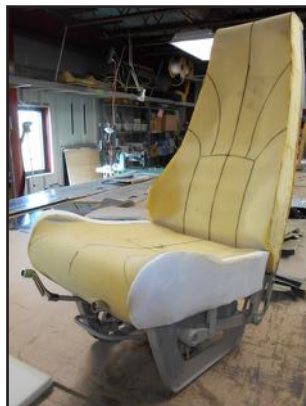
Renovated and foamed seat with the new upholstery design laid out and ready for patterning, sewing, and mounting.

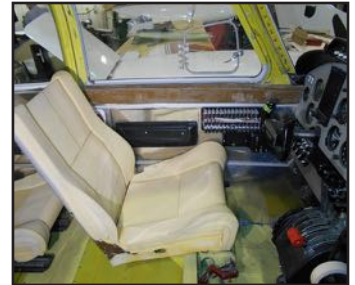
The all-important check of temporarily installed but still unupholstered interior components to closely check for proper clearance, security, and function of each component.

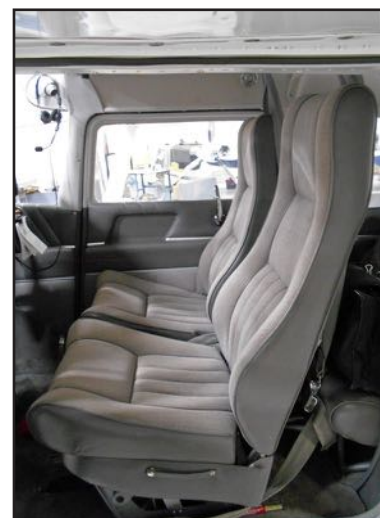
*Fabric and leather interior with corded seats after 27 years and 1000 hours of use. No wrinkles, sagging or seam failures. My wife Cynthia is tired of the color, but it's not getting changed!*

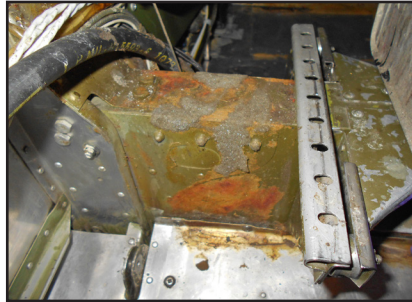
Typical corrosion-prone mess caused by gluing carpet to a spar carry through.

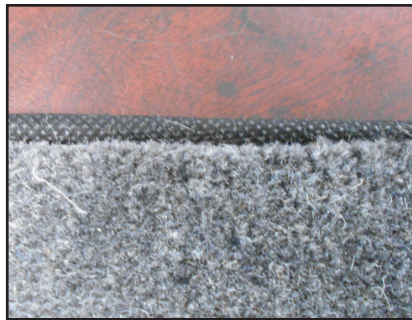
The finished product, all done with a walking foot needle feed upholstery sewing machine. No complicated and expensive carpet serger required.

After stitching the edge tape material to the edge of the carpet, the edge tape is rolled under and lightly glued in place. A single stitch is sewn along the edge of the tape. The last step is to neatly trim the surplus edge tape material on the back of the carpet.

edge to a carpet: The first method is to use thin vinyl or cloth edge tape that can be 1¼ to 2 inches wide. The tape is positioned at the edge of the top surface of the carpet, then stitched in place, about 3/8" in. The tape is then rolled over the raw carpet edge and lightly glued to the back of the carpet. The carpet is then turned right side up and a line of stitching is done along the inside edge of the tape. Depending on the width of the edge tape being used, any excess can be trimmed (from the back) after stitching is complete. The photo shows it all.

This is an inexpensive method of finishing a raw carpet edge and, if done carefully, will produce professional results. A big motivation for using the edge tape system is that all sewing can be done with a walking foot, needle-fed commercial machine that is the same machine used for sewing seats and side panels.

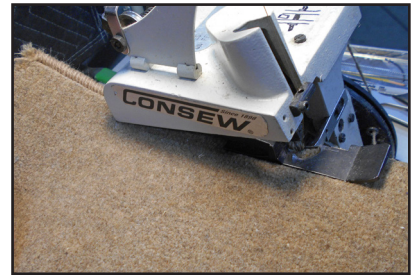
A carpet serger in action sewing a neat loop of color-matched serging thread to the edge of a new section of floor carpet.

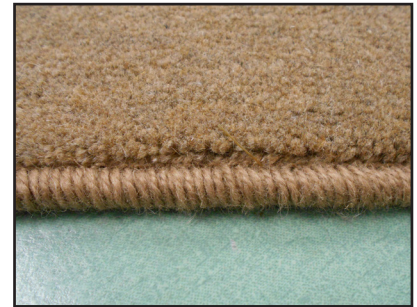
Neat and durable serging.

The second method of finishing a raw carpet edge necessitates the use of an expensive and complex carpet serger. This involves applying a closely stitched loop of thick, color matched yarn around the perimeter of the carpet. This process is widely used in the carpet world. The serging method creates a very nice-looking finished edge that is not only faster to execute but can be easily repaired if the serging yarn is damaged. If an edge loop is broken, all one needs to do is tuck off the two broken ends of the yarn and hand-stitch and tie off a short section of serging yarn, neatly filling in the gap created by the break. On the other hand, if the earlier described edge tape is damaged, the only good fix is to remove all of the edge tape on that particular piece and apply new tape. I definitely prefer serging!

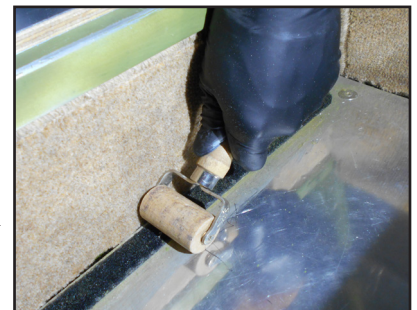
Firmly pressing velcro in place with a wood roller.

used in these products is, well, not particularly good. In our experience, this stuff has a great potential for failing in time. We use sprayable and brushable adhesive called MC5 (we purchase locally from Miami Corporation). When bonding Velcro to the floor, begin by brushing two coats on the back of the Velcro as well as two coats on the cleaned metal floor surface. Read the instructions on the can and allow proper set-up time in between applying the adhesive and bonding the Velcro to the metal. We use a wood roller to ensure that the Velcro is firmly pressed in place on the floors.

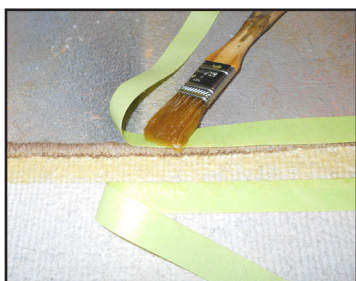
*Neatly applying adhesive to the rough backing surface of carpet.*

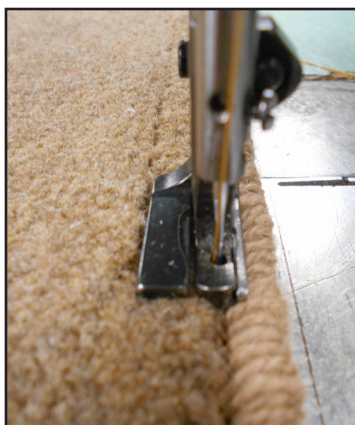
*Running a 'stitch in the ditch' that permanently secures the bonded in place Velcro to the back surface of the new floor carpet.*

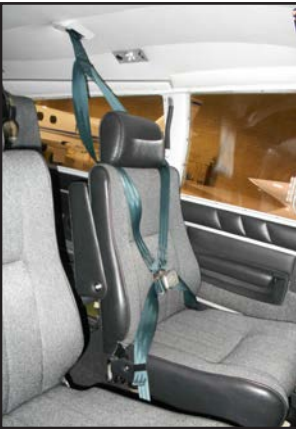
BAS four-point inertia reel shoulder harness/lap belt installation in a Cessna 310.

If you are flying an older Twin Cessna that does not have shoulder harnesses, particularly for the front seats, I would advise that you work with your maintenance technician to purchase and install an approved four-point inertia reel system.

free movement while performing pilot duties such as switching fuel tanks or leaning forward while looking for traffic. An inertia reel always keeps the harness comfortably and correctly located diagonally across the occupant's upper body by automatically extending and retracting during movement. If a sudden deceleration force is sensed by the mechanism in the inertia reel, it instantly locks up and holds the occupant in place.

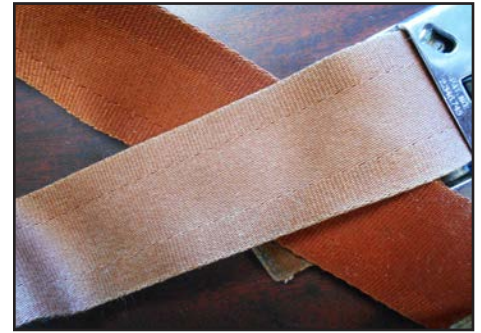
Sun faded 45-year-old Cessna lap belt.

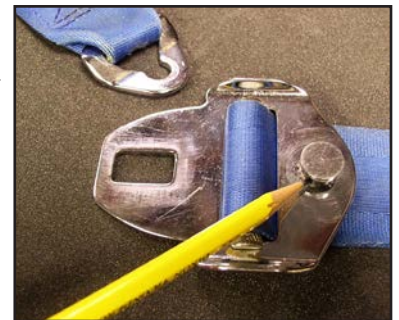
*Worn nylon bushing in a shoulder harness attach fitting.*

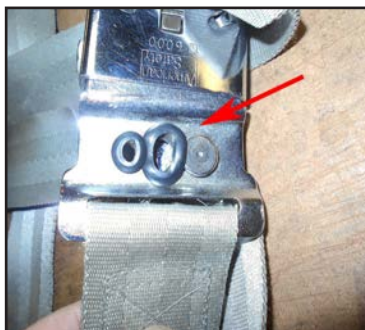
*Homemade attempted fix for a worn attach fitting that employed the use of a rubber O-ring.*

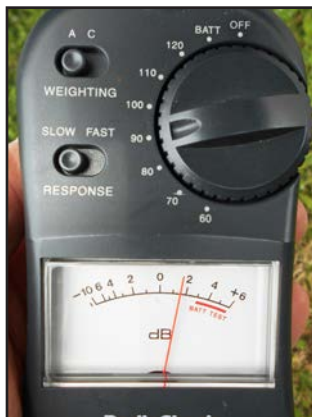
Analog meter indicating a  
92 db sound pressure level.

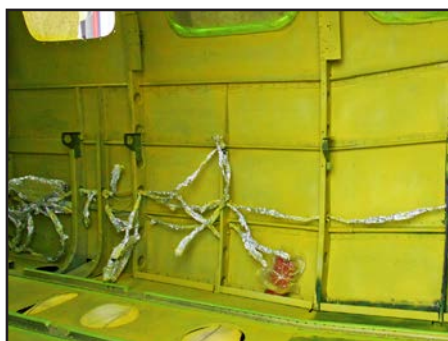
Thoroughly cleaned, corrosion-free,  
chromated cabin, ready for the new  
insulation package.

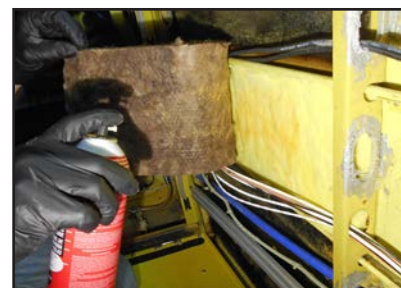
Neatly fit double layers of  
fiberglass insulation being lightly  
bonded in place with Camie 303  
spray adhesive.

two types of fiberglass. We first begin by bonding a 5/8" thick layer of semi-rigid fiberglass to the cleaned and chromated cabin skins. Bonding this semi rigid fiberglass to the cabin skins will reduce skin vibration, thus reducing noise transition into the cabin. We actually buy 2" x 4' fiberglass ceiling tiles with the finish layer removed. We use spray contact adhesive, available in 18-ounce cans sold under the brand name of Camie 303. We spray a light coat

of adhesive on both the 5/8" semi-rigid fiberglass and the chromated surface of the cabin, and press the cut-to-shape fiberglass in place. In order to get the semi-rigid panels to conform to a curved surface simply make parallel half-thickness cuts to the bonded side of the panel. Never attempt to apply contact adhesive to fiberglass with a brush; this will result in impregnating the non-combustible fiberglass with too heavy a layer of combustible adhesive.

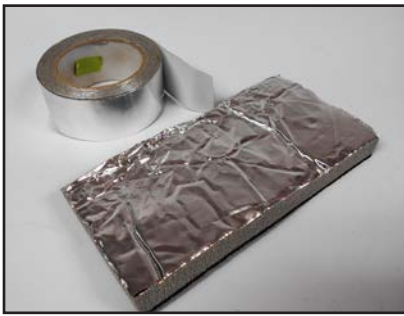
*Sound Ex composite insulation with inside-facing foil; the foil tape is used to hold the Sound Ex in place.*

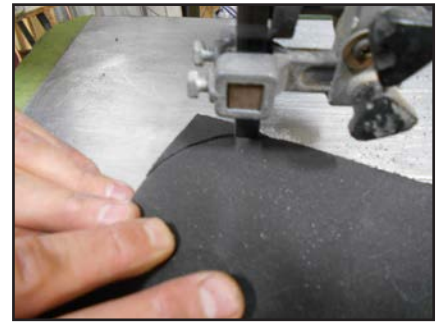
*Using a band saw to quickly and neatly cut out the Sound Ex.*

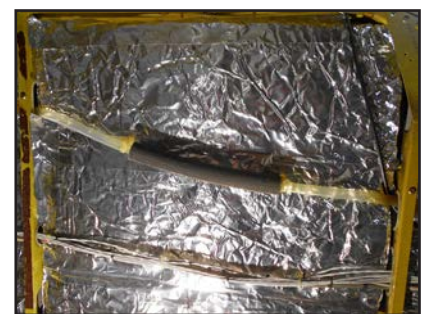
*Neatly installed Sound Ex material that allows exposure of cabin plumbing and wiring.*
