310 GEAR RIGGING

by Greg Ortega & Captain Mike Ward, TTCF Members

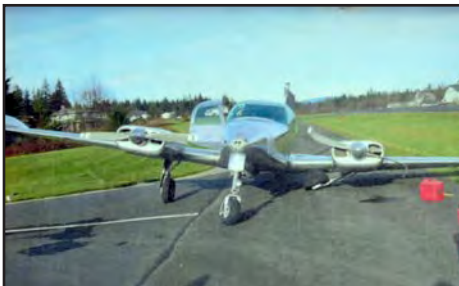
My 1958 310B after its landing gear failure a few years back.

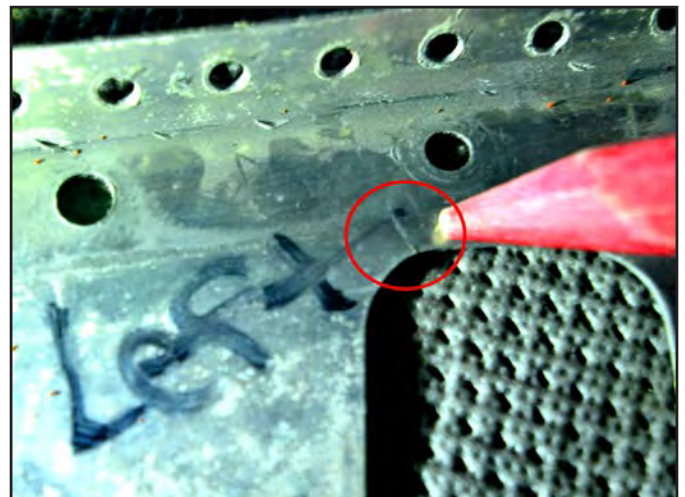
Cracks like this are not uncommon for Twin Cessna landing gear. They must be repaired.

Close inspection of the wheel well structure revealed the dreaded cracks as described in both the "Rig It Right" brochure and video. Even though our cracks were small and minor in nature, we made the decision to install the optional Cessna 310 Side Brace Kit. Note that when ordering this kit, the parts are aircraft serial number specific.

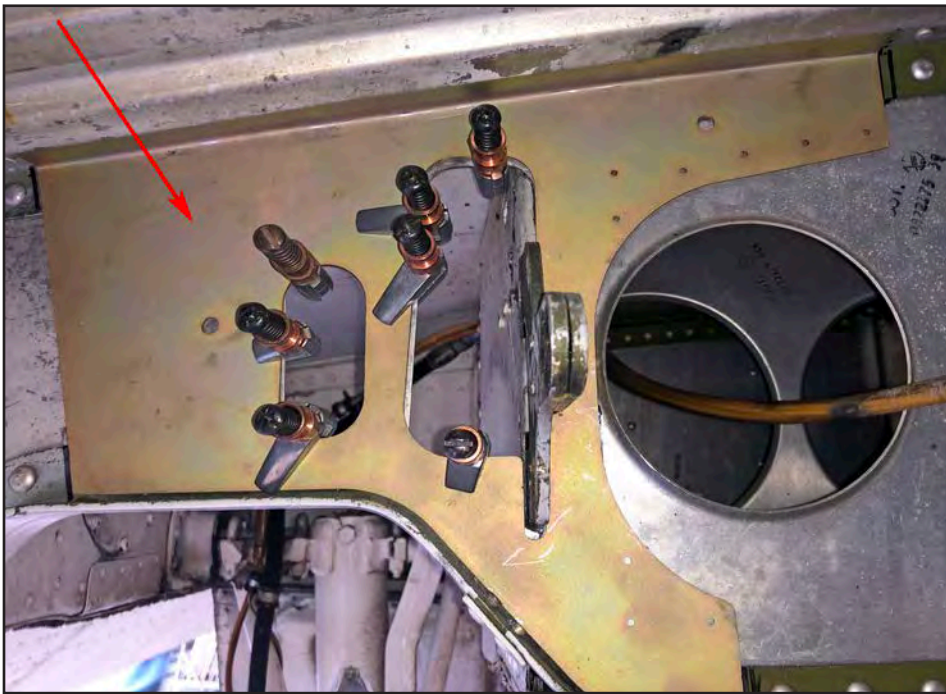
The doubler plated used for the crack repair.

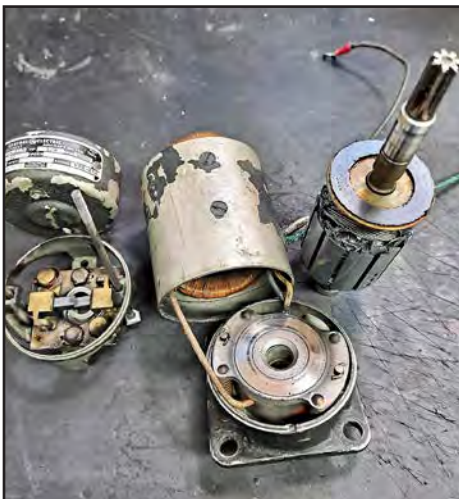
The stops on my landing gear motor were out of tolerance and the motor brake plate had glazed over. We sent it out for overhaul.

We found that the stops on the landing gear motor were out of tolerance. This was a rebuilt motor with only 44 hours and

Aircraft Accessories in Tulsa did the work and they were great to work with. Even though out of warranty, they made good on the repair. Inspection revealed that the brake plate in the motor had glazed over, which reduced motor braking beyond acceptable limits.

less than 40 cycles. So out comes the motor to go back for another rebuild.

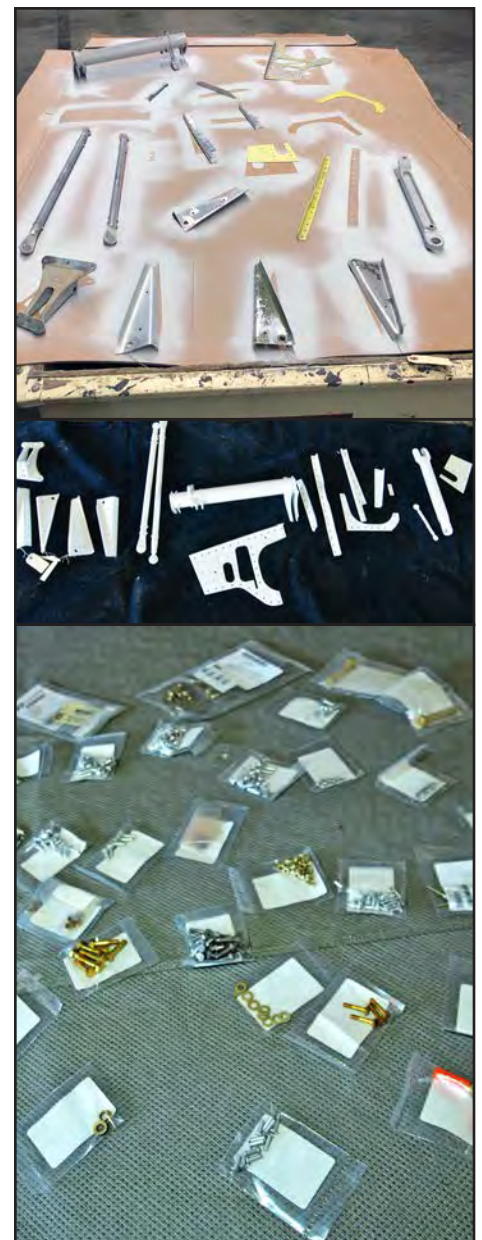
Landing gear parts and hardware. We removed, cleaned, and repainted all the parts.

Eventually all of the parts were sourced using four different vendors. Once all of the items were on hand and organized, reassembly began. As we pulled parts off of the airplane that were reusable, we cleaned and repainted the components with two part epoxy as necessary.

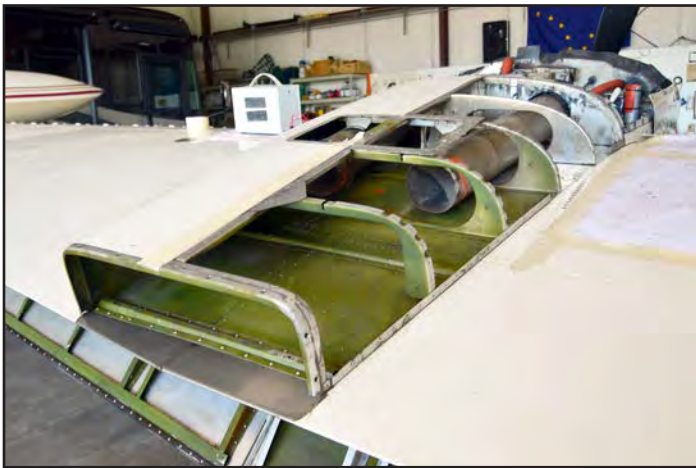
Someone suggested that while doing the landing gear work we also inspect my exhaust mufflers. We did and they needed replacing.

mufflers was cracked and both augments tubes needed replacing.

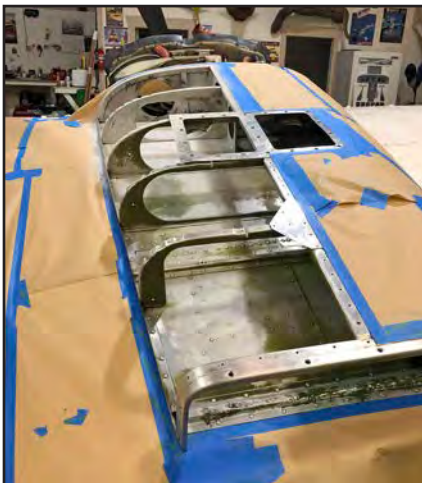
Here we have the muffler cowling removed, looking for corrosion to repair, and preparing to paint.

Once we had the cowling components disassembled, we then cleaned and repainted all of the parts before reassembly.

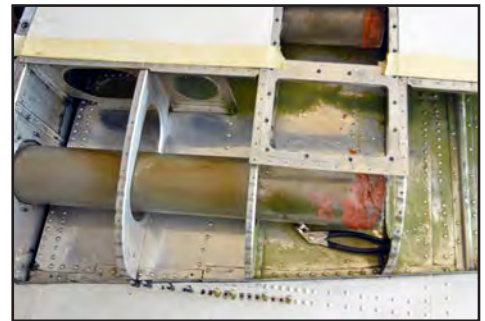
Good view of the augmentor tube inside the unpainted muffler cowling interior.

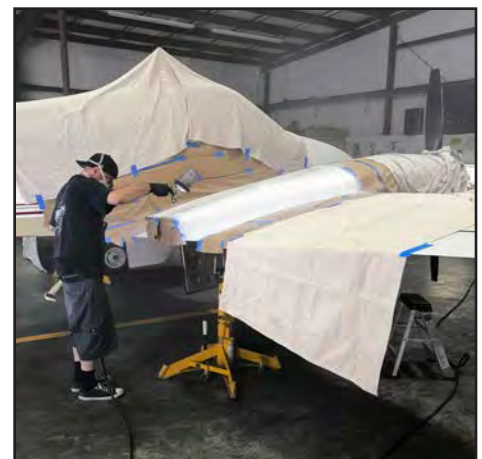
The final painting after all the work was completed.
